FIG. 255.—LOWER DAM, OR "PRESA DE LA OLLA," GUANAJUATO, MEXICO. VIEW TAKEN DURING THE FEAST DAY WHEN THE GATES ARE RAISED AND THE RESERVOIR EMPTIED.

The chapter on Masonry Dams has been increased twofold by an attempt to make some mention of all the most notable dams of the world, and many that are very little known. Attention is particularly directed to Plates 1, 2, and 3, in which profiles are shown of all of the leading and better known masonry dams in existence, drawn to uniform scale for easy graphical comparison. No such complete collection of dam profiles has ever before appeared in print, assembled together on a common basis.

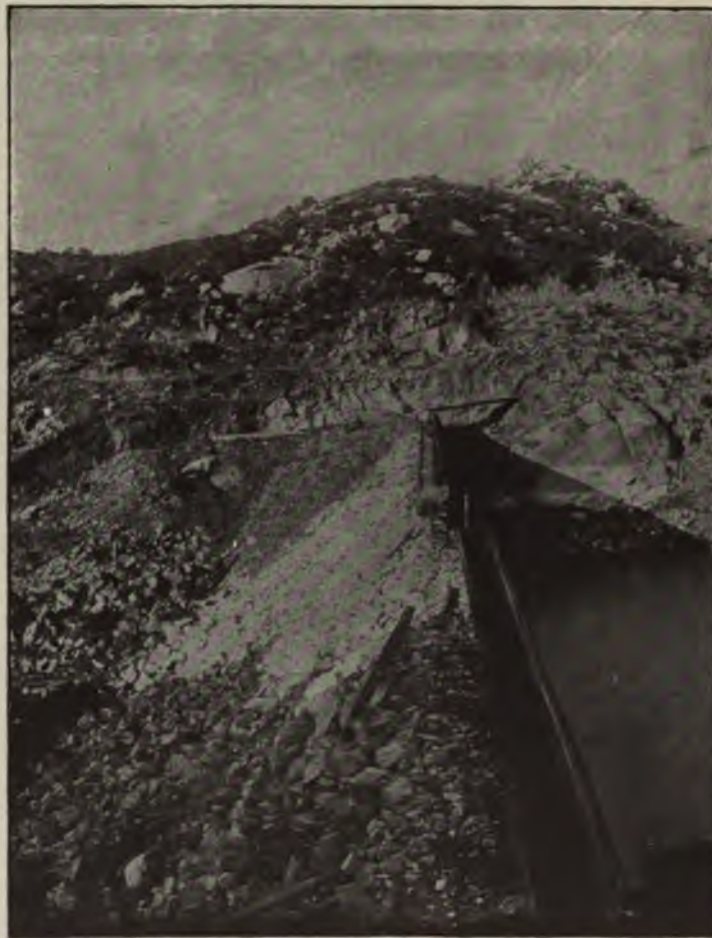
FIG. 4.—ESCONDIDO IRRIGATION DAM, LOOKING NORTH, SHOWING SPILLWAY.

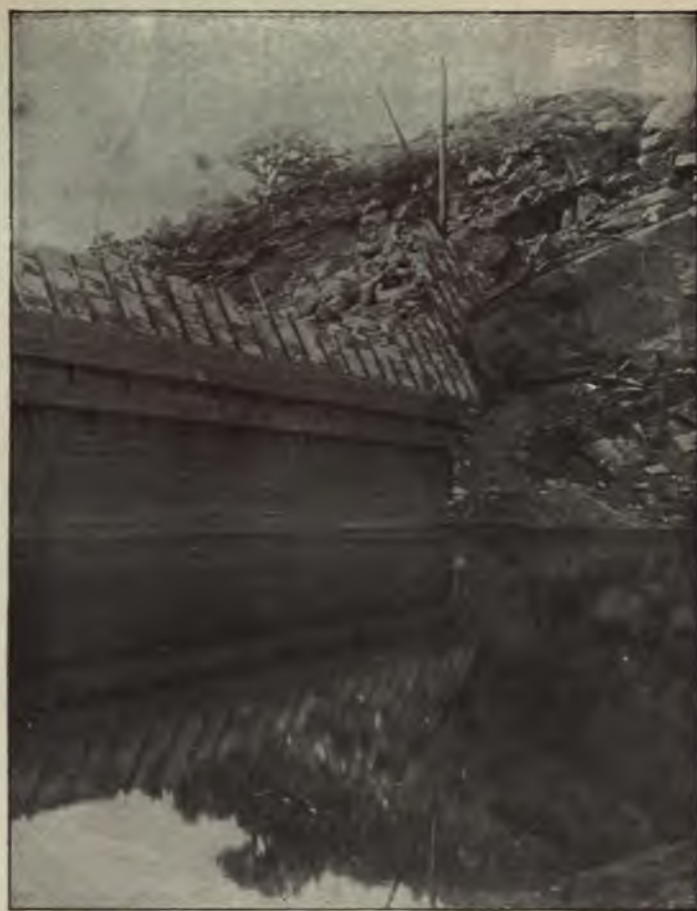
FIG 9.—CONSTRUCTION OF FACING OF ESCONDIDO DAM.

connected all around the toe with the canyon walls and bed. The dry wall forming the upper face of the dam was so laid as to embed in its surface a series of redwood timbers, 6" x 6" in size, placed in vertical parallel lines, 5 feet 4 inches apart between centers. These timbers projected 2 inches beyond the face of the wall, and the planks were spiked to them. As each row of plank was put in position, beginning at the bottom, concrete was rammed into the 2-inch space between the plank and the face of the wall, giving a full bearing for the plank throughout. This provision was certainly a wise one, and so far as the writer is informed was never employed before in the dams of this class previously constructed. On the lower third of the dam the facing plank are 3 inches thick, on the middle third 2 inches, and on the upper third 1½ inches, all being doubled throughout. Joints were broken as far as possible, both at the vertical and the horizontal seams, by the second layer, and they were calked with oakum and smeared with hot asphaltum.

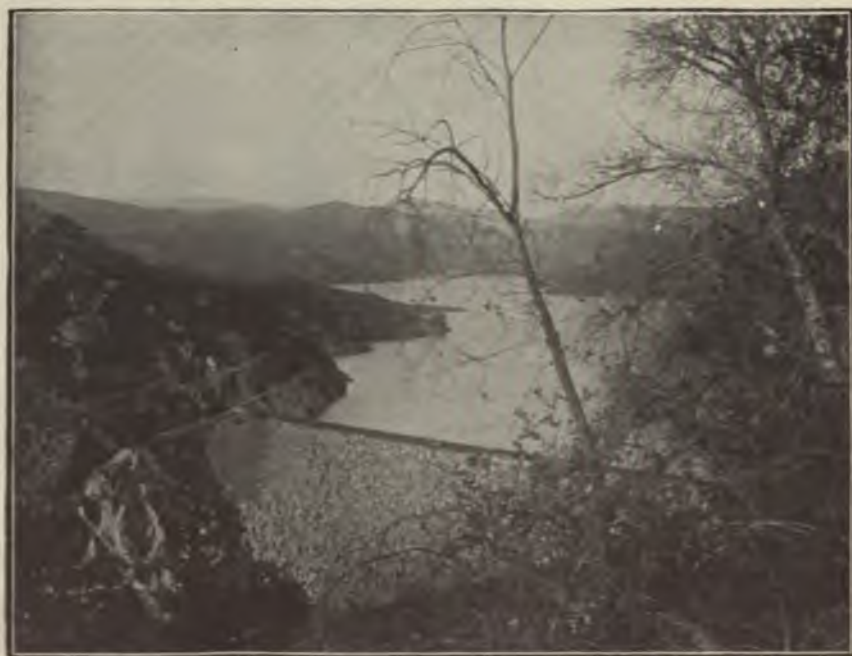
FIG. 10.—ESCONDIDO (CAL.) ROCK-FILL DAM. WOODEN LINING.

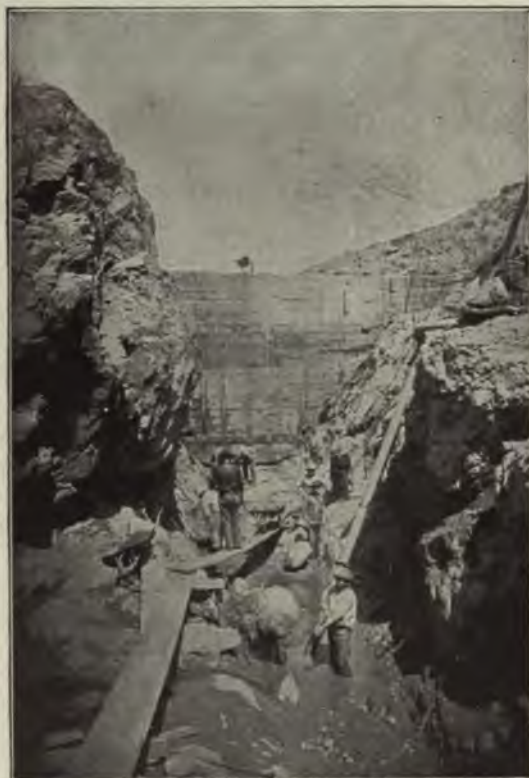
FIG. 11 —MASONRY FOUNDATION OF LOWER OTAY DAM.

The site of the Gray dam was an ideal one for a masonry structure, because of the satisfactory character of the bed-rock foundation, and the abundance of suitable rock and sand at the site, while its convenience to a port of entry rendered the cost of cement very moderate. The usual incentive for building rock-fill dams in preference to masonry, due to their remoteness and the high cost of freight on cement to the site was lacking in this case, and in fact the work was originally planned as a masonry dam. A foundation was laid for this purpose 65 feet thick at the base, reaching down to a depth of 31.4 feet below zero contour, and carried up to a height of 5.6 feet above zero, with a length on top of 55 feet. A view of the work is shown in Fig. 11.

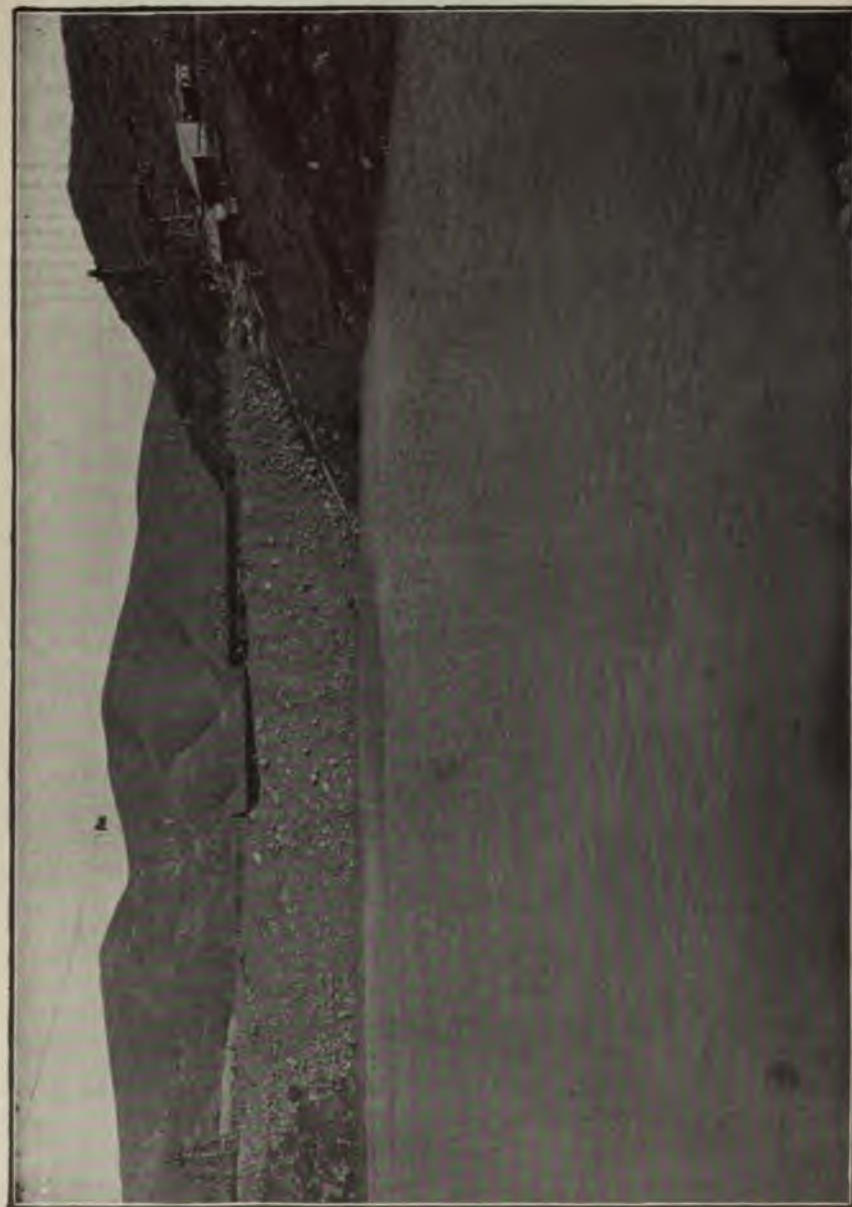
FIG. 12.—OTAY (CAL.) ROCK-FILL DAM—STEEL CORE.

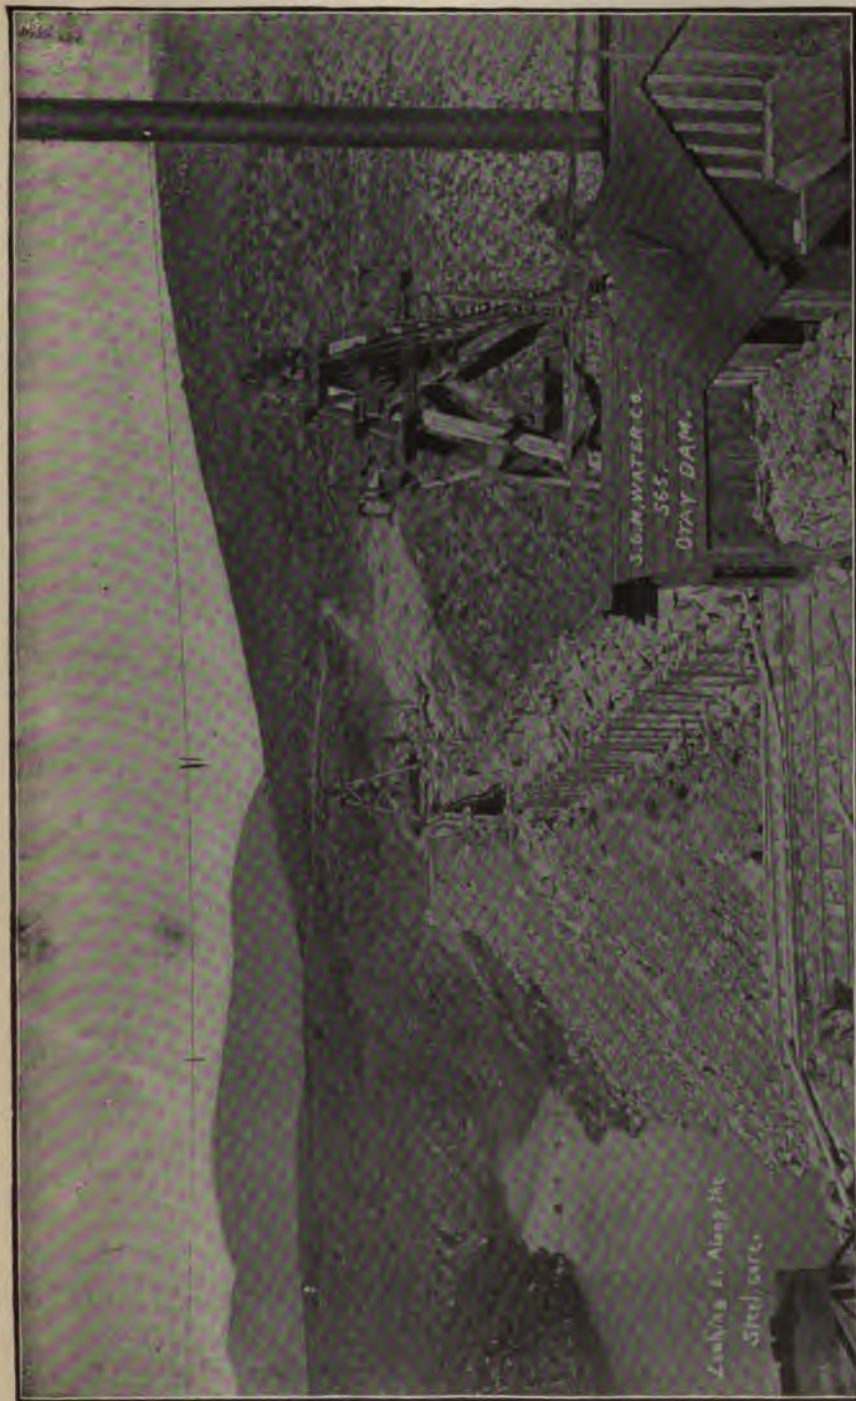
FIG. 13.—OTAY (CAL.) ROCK-FILL DAM—STEEL CORE.

The expansion of the plates after they were riveted together, and the obtuse angle up-stream on which they were first started, which gradually was obliterated by an approach to a straight line toward the top of the dam, gave them a very irregular alignment, as will be seen in Fig. 13, which is a view looking along the top of the dam toward the left bank just before its completion.

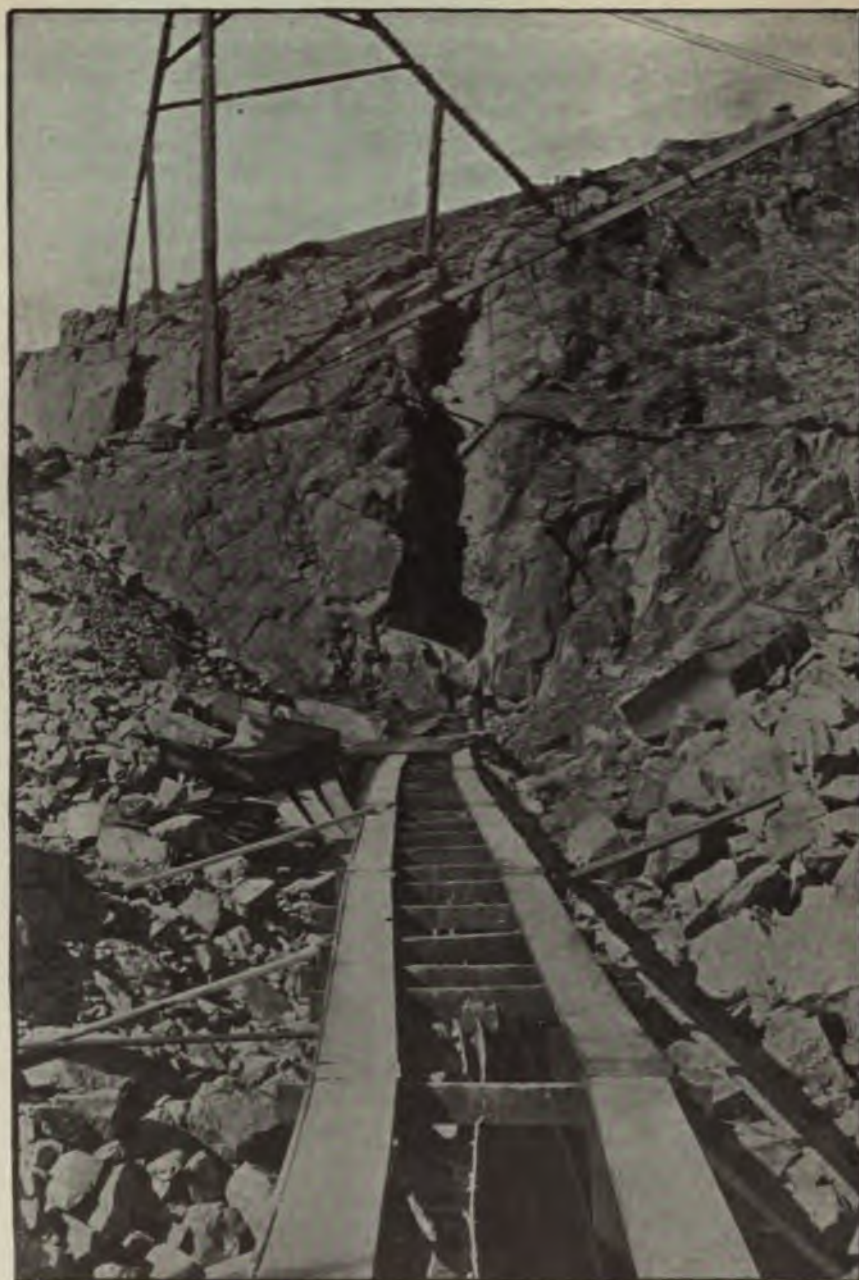
FIG. 14.—STEEL WEB-PLATE AND ANCHOR-TRENCH AT WEST END OF LOWER OTAY DAM.

tapering to 2 feet in a height of 8 feet. The moulds for the concrete, consisting of 1-inch boards laid horizontally and 2×6 -inch vertical posts, were left in position permanently and the rock-fill built against them on either side. The steel core, or web-plate, was carried into the side walls of the canyon in a trench excavated to the depth necessary to reach solid rock and anchored with bolts leaded into the rock. The end plates were not trimmed to fit the irregular line of the rock cutting, but the masonry was widened to a maximum thickness of 20 feet at the sides, tapering from the normal thickness of 2 feet in a distance of about 20 feet. Fig. 14 shows the trench on the right bank about at the 40-foot contour. The function of the wall is to steady and stiffen the web-plate and protect it from injury from the loose rock piled against it, and as the wooden moulds were not removed the embankment is free to settle without injuring the concrete or the plates.

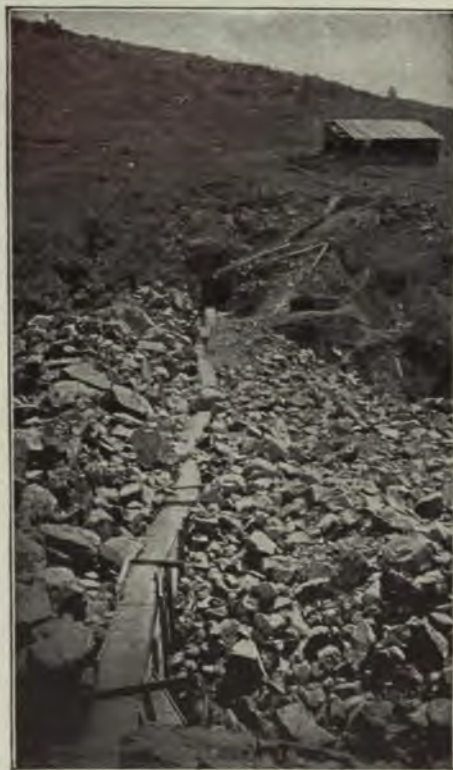
FIG. 16.—CREST OF LOWER OTAY DAM, SHOWING WEB-PLATE OF STEEL EMBEDDED IN CONCRETE. DAM NEARING COMPLETION.

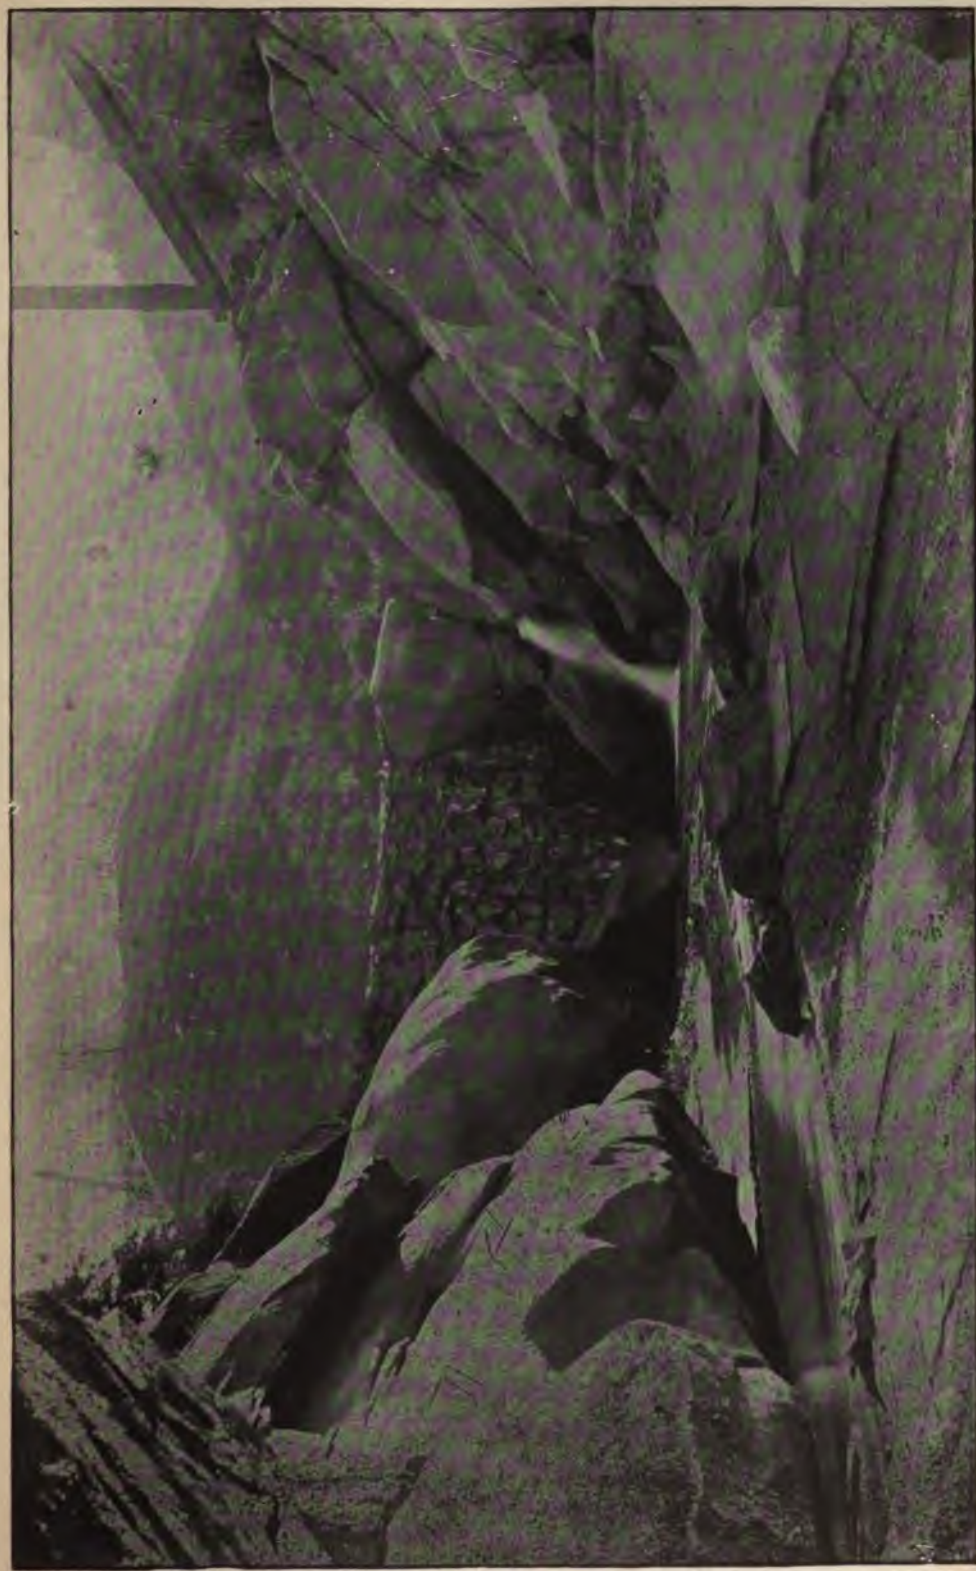
FIG. 20.—THE BARRETT DAM-SITE, SHOWING THE BEGINNING OF MASONRY FOUNDATIONS.
The material on left bank above the rock here shown is disintegrated granite to such depth as to require change of plans from original design.

In 1897 the company erected a masonry dam, shown in Fig. 20, 72 feet in height from its base, which is 22 feet below the stream-bed, to its top 50 feet above. This structure rests on solid granite bed-rock throughout, and is 14 feet thick at bottom, 5 feet at top, and about 30 feet long on the crest. This was to be used simply as a pick-up weir to divert water into the Dulzura pass conduit. Subsequently it was decided to build a storage dam, similar in plan to that of the Lower Otay, to an extreme height of 175 feet, and a new location was chosen about 1000 feet further down stream, where rock could be more conveniently obtained for a rock-fill structure. Here a new masonry dam was built in 1898, reaching to bed-rock in the stream-bed and extending about 35 feet above, upon which to begin the sheet-steel core of the rock-fill. The dimensions were as follows:

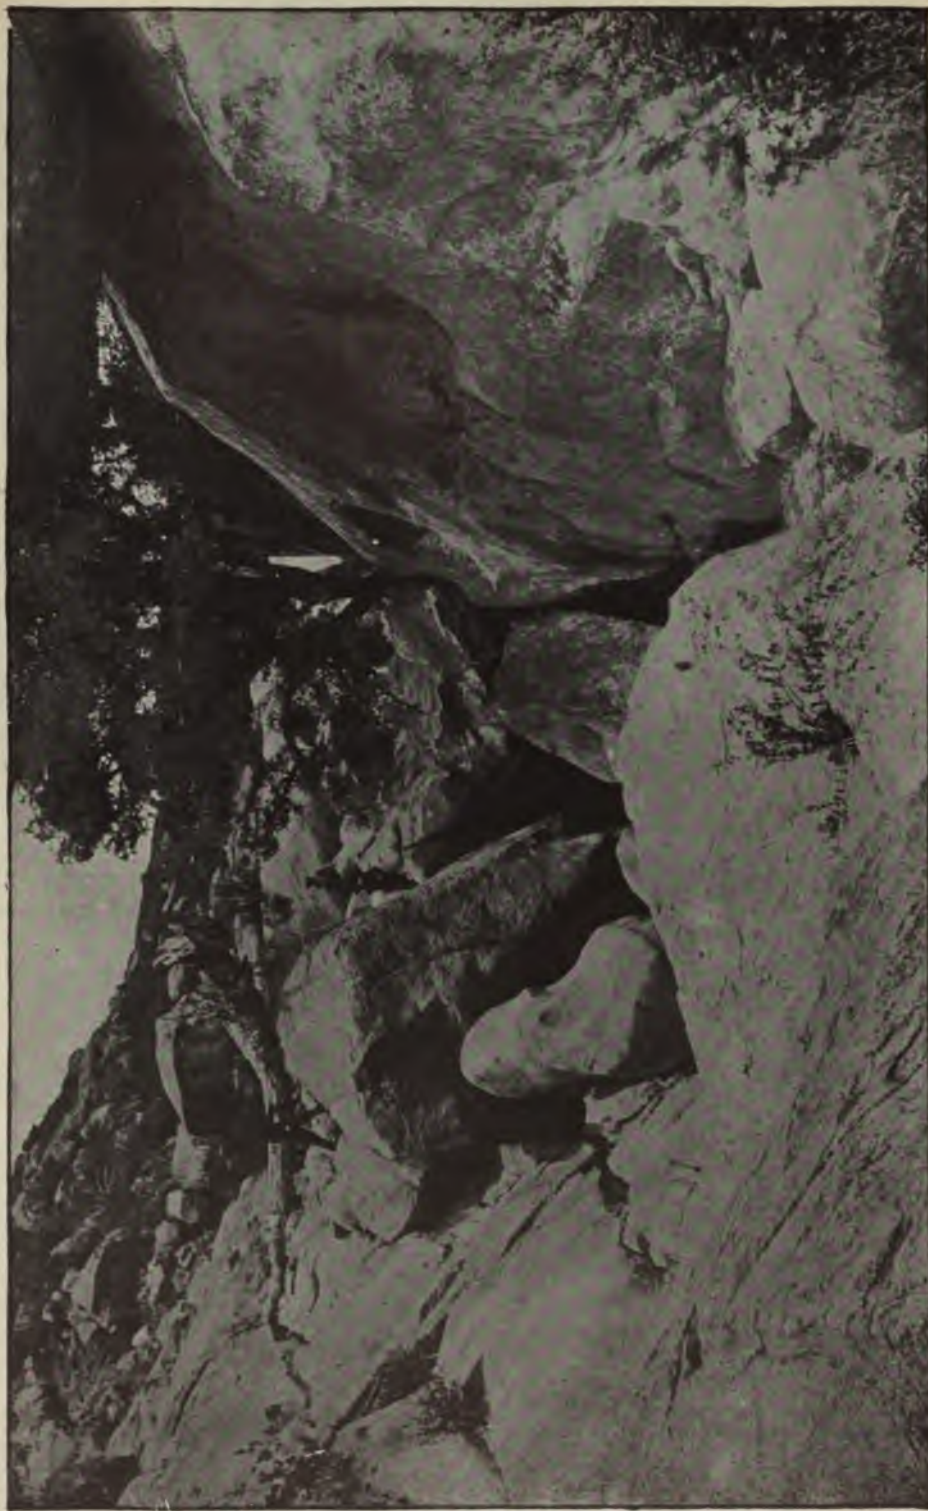
FIG. 21.—MORENA DAM-SITE, LOOKING EAST.

100 feet deep below the stream-bed. Fig. 21 is a view taken of the dam-site looking up stream, and well illustrates the character of the rock-masses filling the gorge. The tree growing at the right of the picture is on the line of the masonry toe-wall. This wall was carried down to the bottom of the fissure, 112.5 feet below the general stream-bed at that point. This wall is at the upper toe of the rock-fill, and is 36 feet thick at the bottom, where the width between solid walls was but 4 feet for a height of 12 feet. The widest part of the fissure was 16 feet, and at the zero contour it was 80 feet wide. At this point the thickness of the masonry was made 20 feet. It was carried up 30 feet higher, where the thickness is 12 feet. The top of the wall is shown in the view of the partially finished dam (Fig. 22) just above the water-line. The upper toe of the rock-fill, which will be finished on a slope of $1\frac{1}{2}$ to 1, will reach to the top of this toe-wall, and will be covered with 5 feet of Portland cement, uncoursed rubble masonry, over which it was intended to lay a sheet of asphalt concrete, 12 inches thick at base and 4 inches thick on top, extending into a groove moulded in the wall, 5 feet in depth. The plan for using asphalt concrete has been abandoned recently and some other material will be substituted. The rock-fill, as shown by this view, is about 80 feet high above the wall.

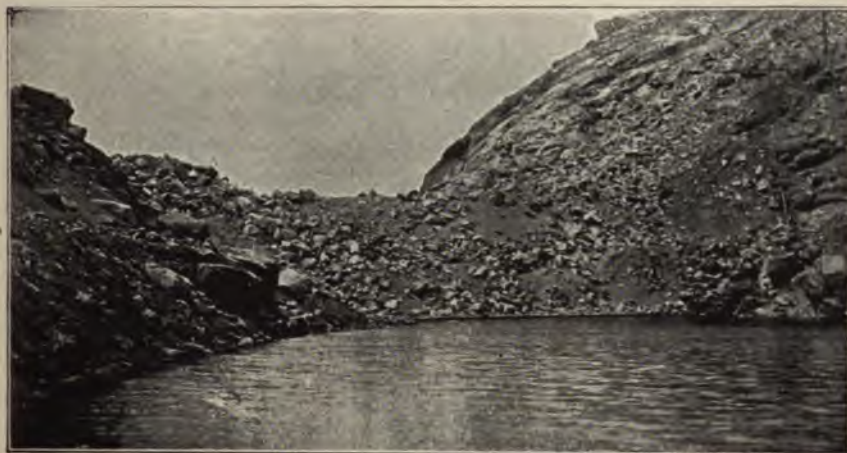
FIG. 22.—MORENA ROCK FILL DAM IN PROCESS OF CONSTRUCTION. SHOWING TOP OF TOE-WALL ABOVE THE WATER-LINE.

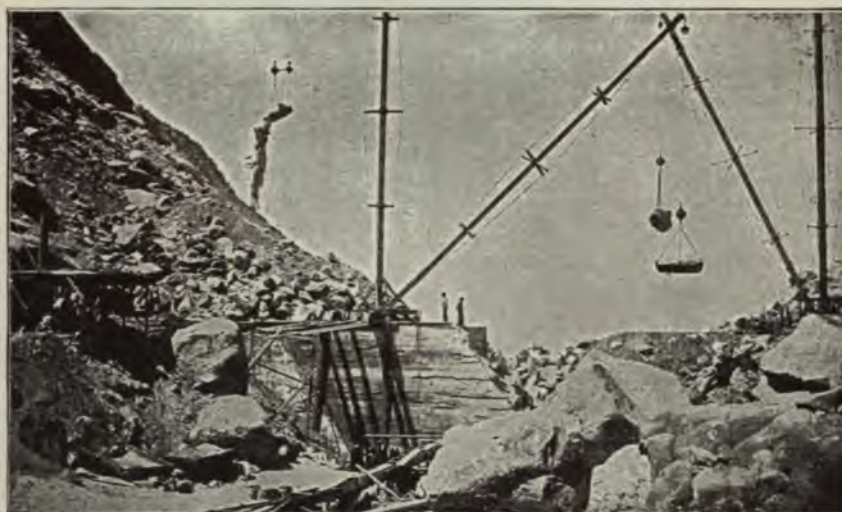
FIG. 23.—MORENA ROCK-FILL DAM, SHOWING A PORTION OF TOE-WALL UNDER CONSTRUCTION.

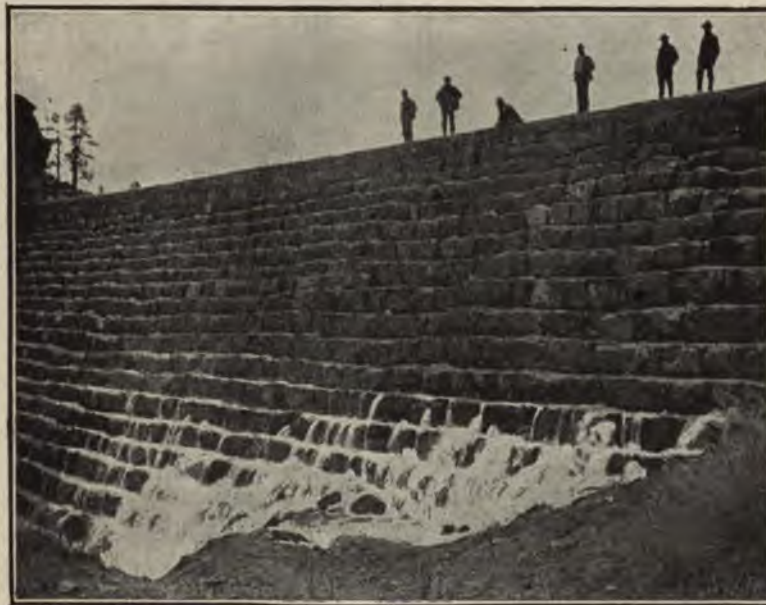
FIG. 30.—CASTLEWOOD DAM, COLO., SHOWING LEAKAGE THROUGH ROCK-FILL.

spillway at the side, while the discharge pipes were wide open. At the same time a large volume of water found its way through the cracks in the masonry wall, and poured out in large streams through the rock-fill for 10 to 15 feet above the base.

The photograph, Fig. 30, shows an enormous amount of this leakage, and the cause for the alarm created in Denver, which lies directly in the path of the escaping water. That the dam was able to withstand such a volume of leakage is a testimonial to the stability of rock-fill dams, which in this case afforded such complete drainage as to be unaffected by leakage that would immediately have destroyed an all-earth dam.

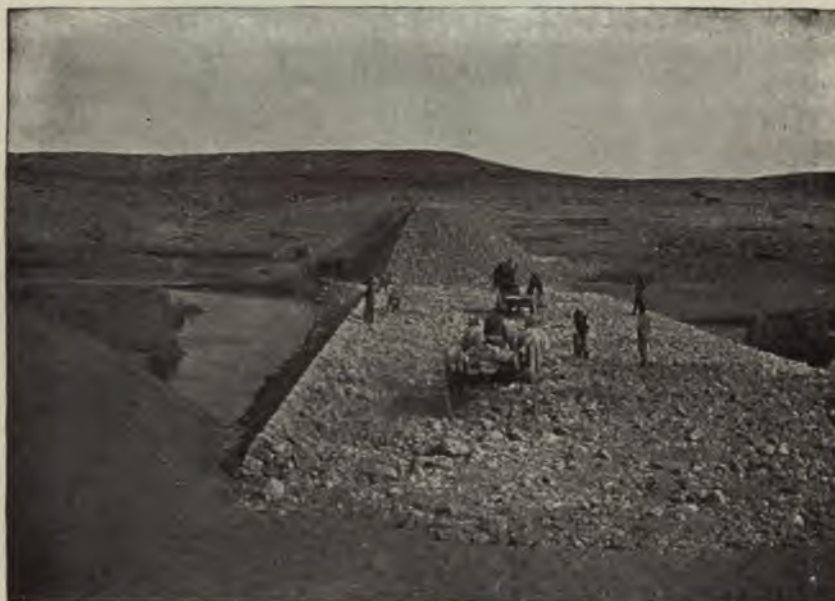
FIG. 33.—LAKE AVALON DAM. ROCK-FILL IN PROCESS OF CONSTRUCTION.

fill before the addition of the earth facing is illustrated by Fig. 33, a view taken during construction. Fig. 34 is a view of the finished dam, taken in 1892. The grade of the main canal leading out from the dam on the east side of the valley is 10 feet above the base of the dam, and is excavated in limestone to a maximum depth of 38 feet. Fig. 35 is a view of the main canal and headgates, taken from the lower side.

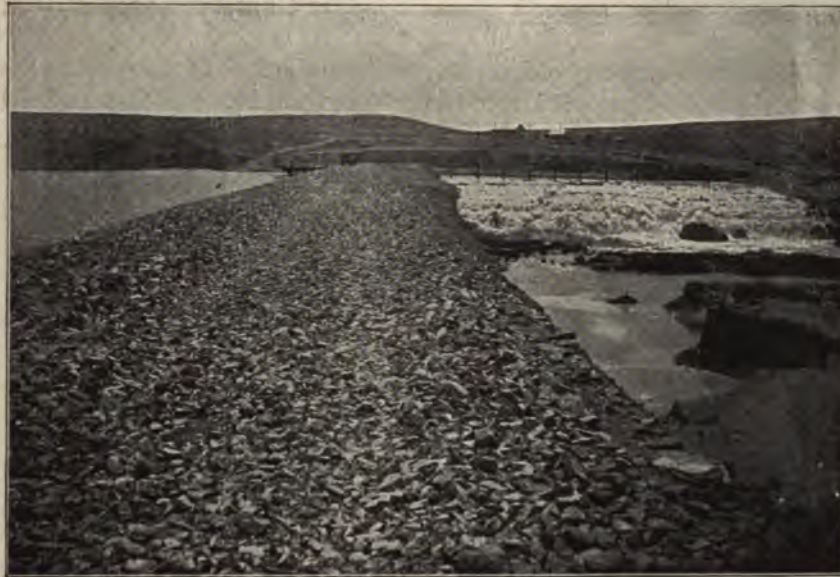
FIG. 34.—LAKE AVALON DAM, PECOS RIVER, NEW MEXICO. SHOWING THE CREST OF COMPLETED DAM AND SPILLWAY DISCHARGING.

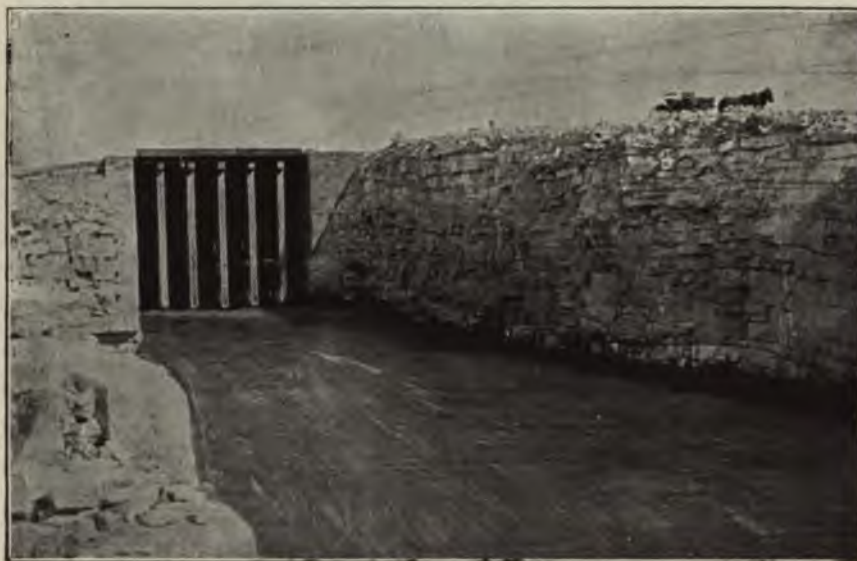
FIG. 35.—CANAL HEADGATES, LAKE AVALON DAM.

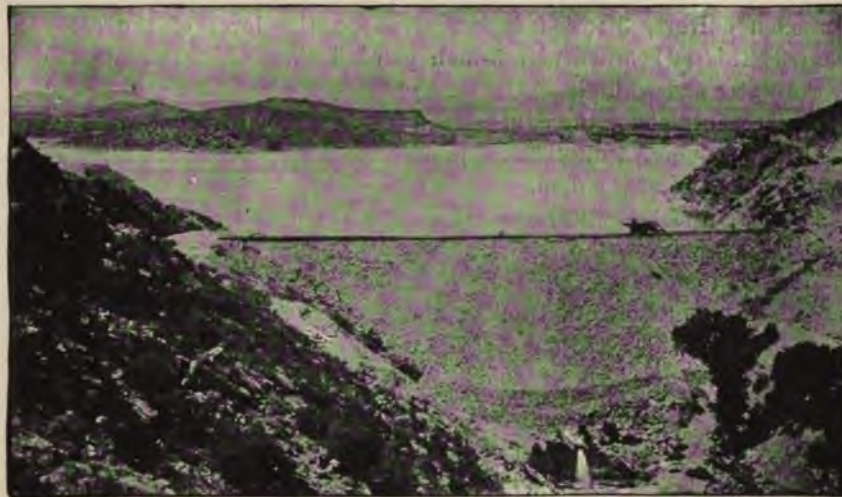
FIG. 41.—VIEW OF WALNUT GROVE DAM, ARIZONA.

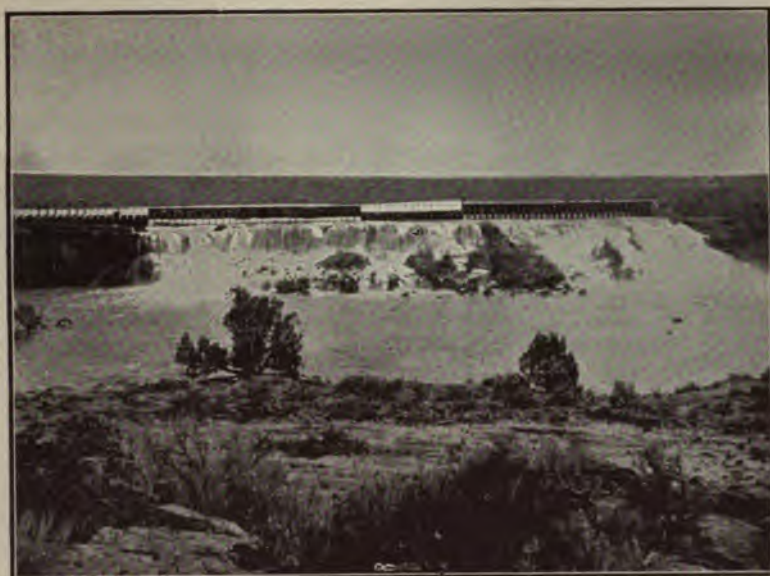
FIG. 47.—MILNER DAM, SNAKE RIVER, IDAHO. DISCHARGE THROUGH THE GREAT BATTERY OF 99 WASTE-GATES FORMING "IRRIGATION FALLS," 40 FEET HIGH.

Figs. 47, 48, 49, 50, 51, and 52 illustrate the construction of these notable dams, and Fig. 53 shows the type of head-gates successfully

The Milner Dam, Idaho.—The photograph shown in Fig. 355 gives a more comprehensive picture of the three combination dams described on page 60 than any of the other illustrations accompanying the article (see Figs. 47 to 53), and will therefore add to the interest in these important and successful dams.

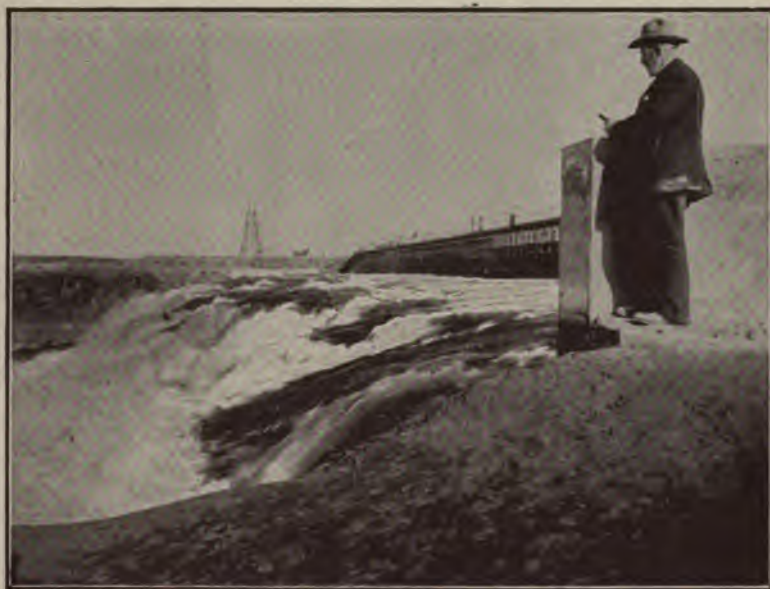
FIG. 48.—MILNER DAM, SNAKE RIVER, IDAHO. SHOWING WASTE-WAY GATES AND DISCHARGE OF RIVER OVER "IRRIGATION FALLS."

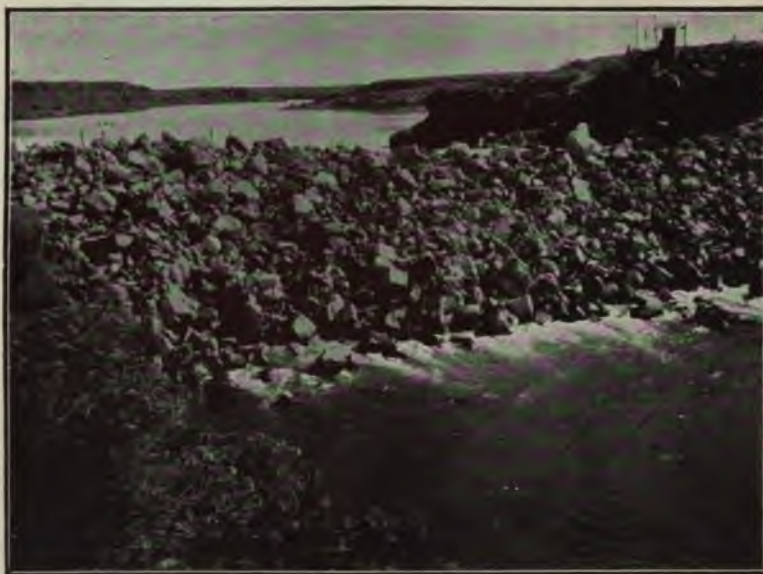
FIG. 49.—MILNER DAM, SNAKE RIVER, IDAHO. NORTH CHANNEL DAM BEFORE COMPLETION OF SHEET PILING. ABOUT 500 SECOND-FEET IS PASSING THROUGH ROCK-FILL, UNDER HEAD OF 13 FEET.

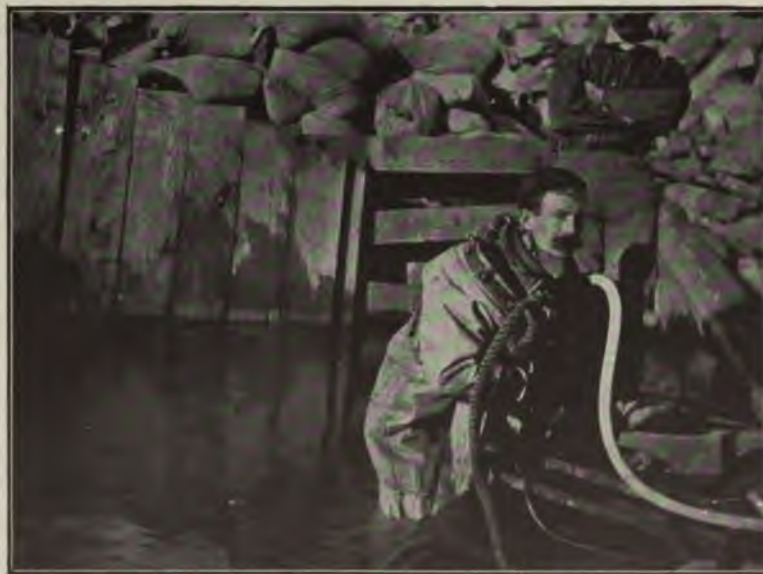
FIG. 50.—MILNER DAM. DIVERS AT WORK PLACING SHEET PILING IN 40 FEET OF WATER.

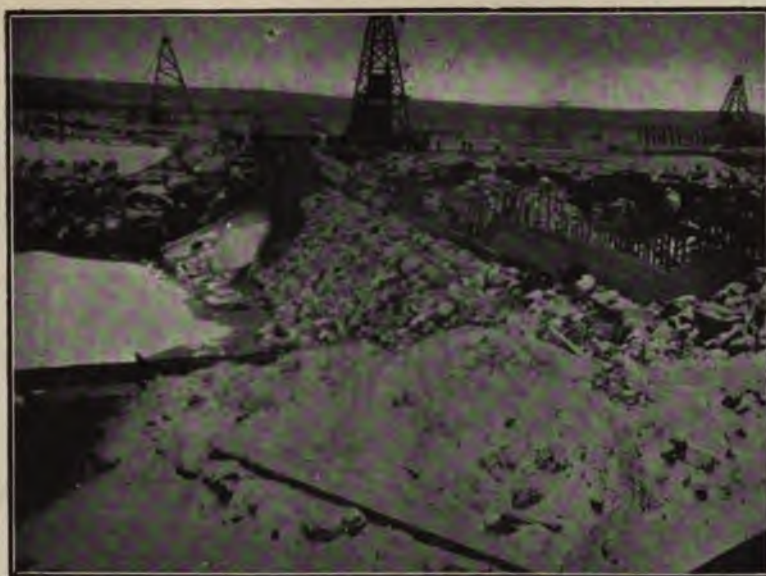
FIG. 51.—MILNER DAM, SNAKE RIVER, IDAHO. SHOWING ROCK-FILL WITH WOOD-CORE IN MAIN CHANNEL OF RIVER.

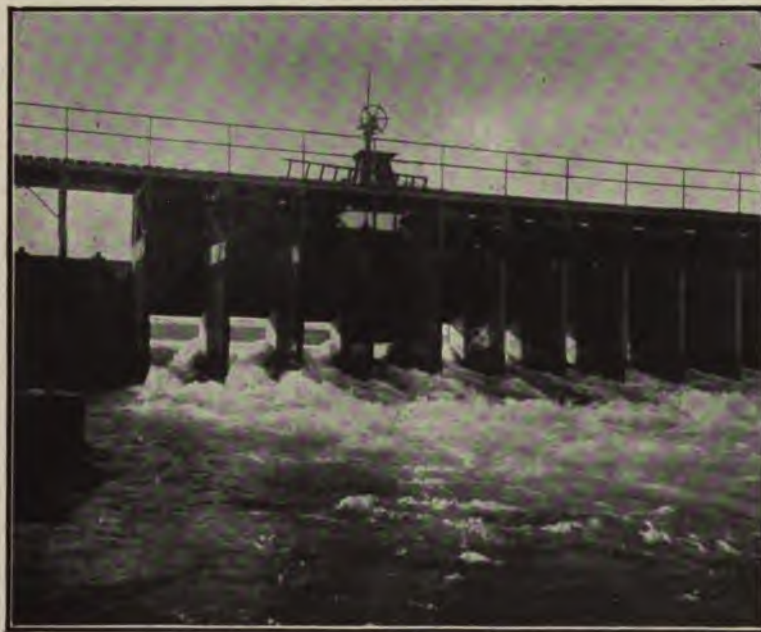
FIG. 52.—MILNER DAM, IDAHO. SHOWING A PART OF THE BATTERY OF 99 WASTE-GATES.

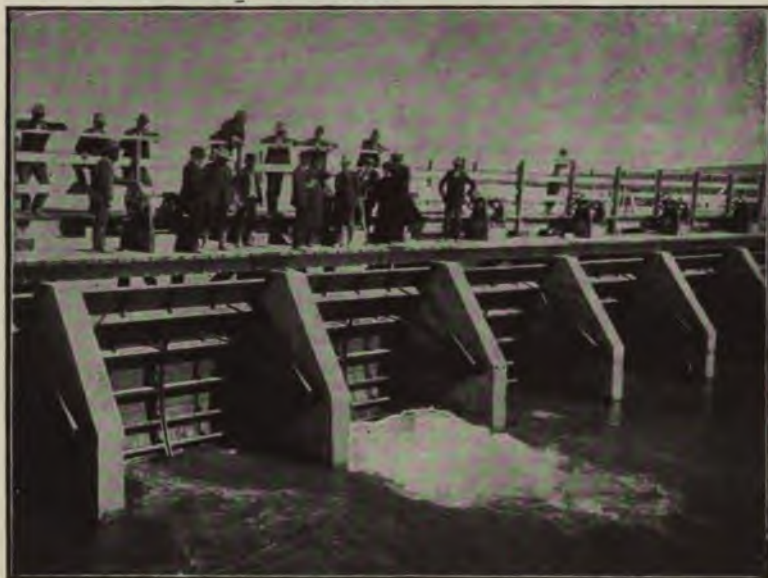
FIG. 53.—FIRST OPENING OF HEAD-GATES OF TWIN FALLS CANAL, MARCH 1, 1905.

used in the canal. They are eight in number, each 12 feet wide and 11 feet high. For description of hydraulic filling of these dams see pages 125 and 126.

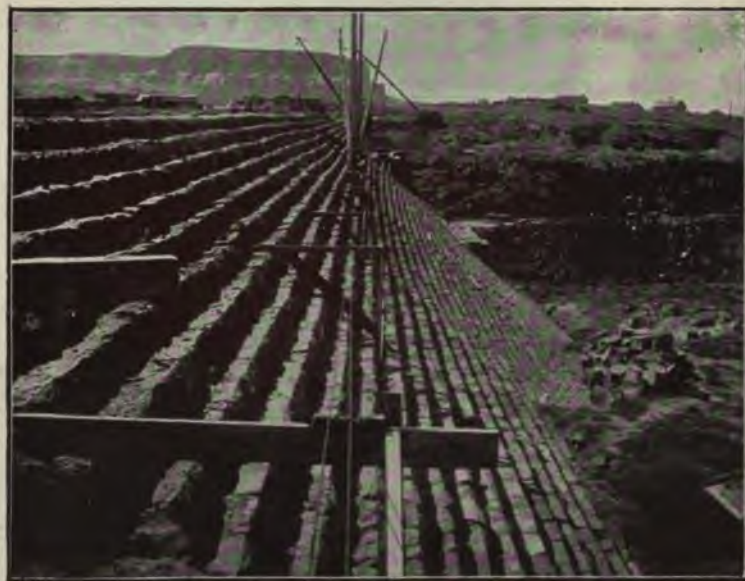
FIG. 55.—DOWN-STREAM FACE OF ZUÑI DAM. SHOWING CHARACTER OF DRY MASONRY IN THE ROCK-FILL.

Fig. 58 is a section of the dam, and Figs. 55, 56, 57, 59, 60, and 61 are photographs taken during construction.

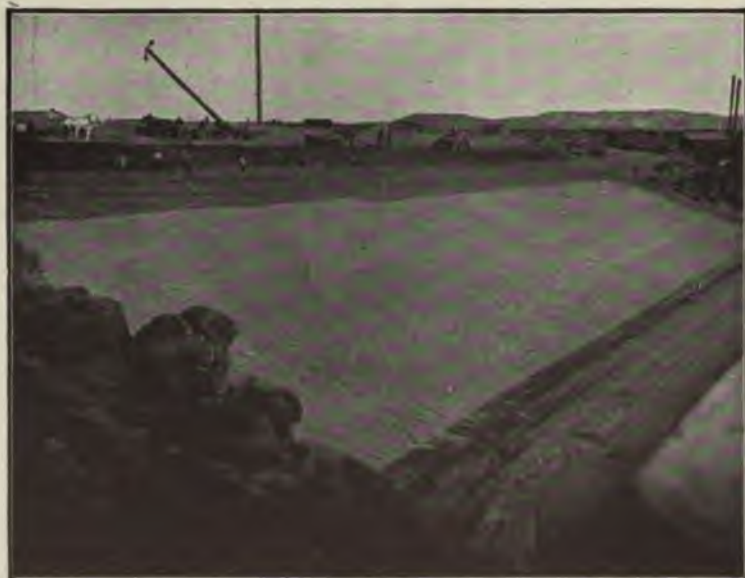
FIG. 56.—HYDRAULIC-FILL SIDE OF ZUÑI DAM. SHOWING GRAVEL COVER OF STONE RIPRAP.

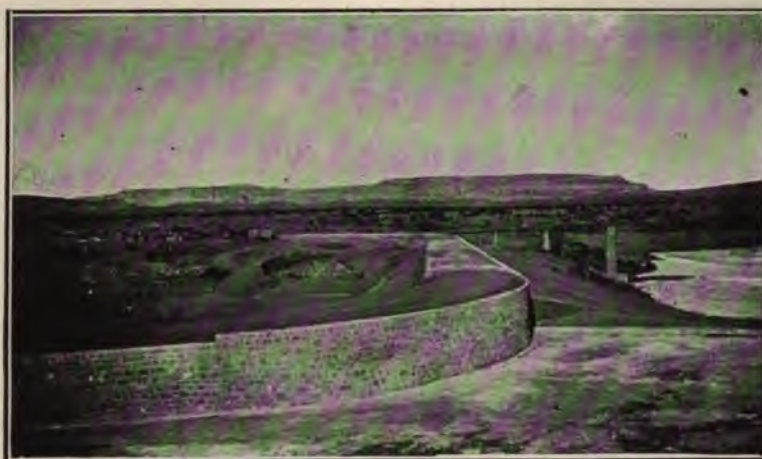
FIG. 57.—ZUNI DAM, N. M., LOOKING NORTH, SHOWING TOWER AND BRIDGE IN DISTANCE, SPILLWAY GUARD-WALL IN FOREGROUND.

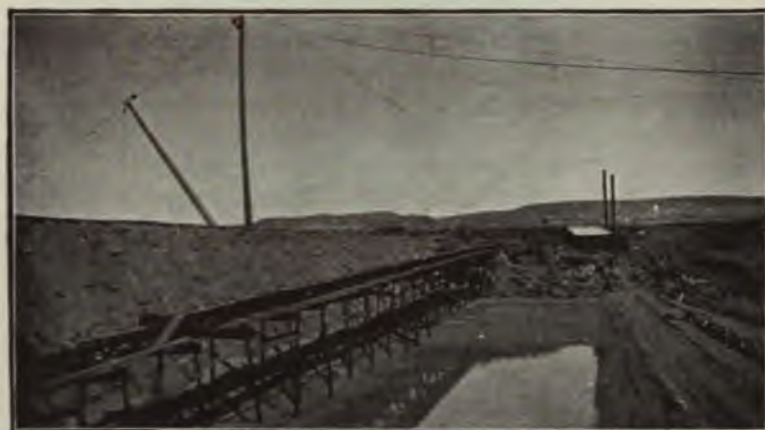
FIG. 59.—ZUÑI DAM, N. M., ILLUSTRATING METHOD OF DELIVERY OF SLUICED MATERIALS BY "V" FLUME, AGAINST FACE OF ROCK-FILL.

of sluicing was 12 cents per cubic yard, of which one-third was for pumping. The material was delivered along the dam by a "V" flume, measuring 20 inches on the sides, laid on a grade of 3%, and consisting of a

succession of sections, each 16 feet long, overlapping at the ends, and made to deliver material at any point by lifting out a section and inserting a lateral flume, directing the stream to either side as desired. Nearly one-half the entire amount of earth sluiced was deposited in the month of May, 1907, when the average delivery was 750 cubic yards per day

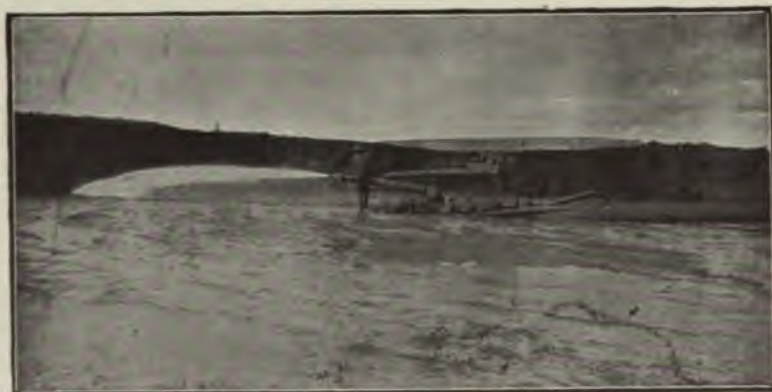
FIG. 60.—ZUÑI DAM, NEW MEXICO, SHOWING HYDRAULIC MONITOR IN ACTION.

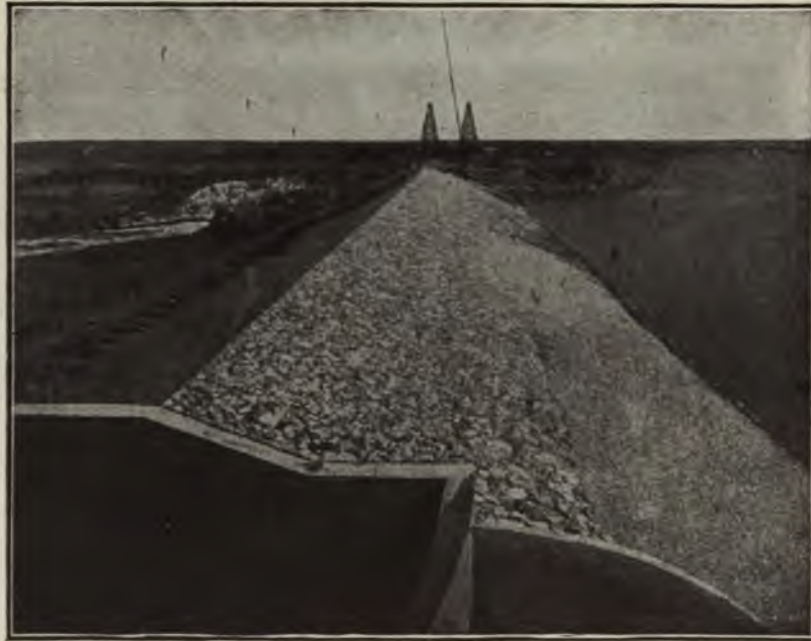
FIG. 61.—MINIDOKA DAM, IDAHO, LOOKING NORTH.

The dam is a rock-fill structure, with earth facing and concrete core-wall. The length of the dam is 625 feet, its maximum height 80 feet above bed-rock, and about 60 feet above the original bed of the stream. The width on the crest is 25 feet, its base averages about 300 feet, and its total volume 191,000 cubic yards. The concrete core-wall is built upon a solid rock foundation throughout the entire length of the dam, and at each end reaches to within about 11 feet of the top of the earth and rock part of the dam, while through the central portion its top is 44 feet below the crest of the dam. The downstream portion of the dam was built of large rocks, of 1000 pounds

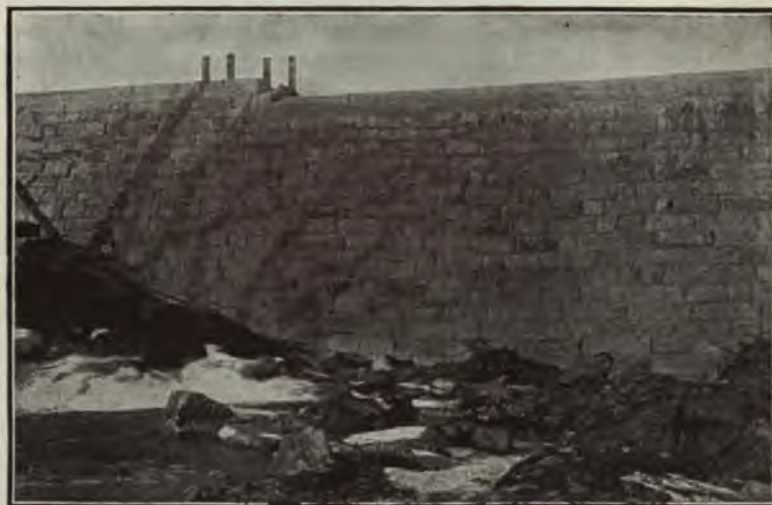
FIG. 63.—ALFRED DAM, ME. DRY ROCK MASONRY WITH CONCRETE FACING AND CREST.

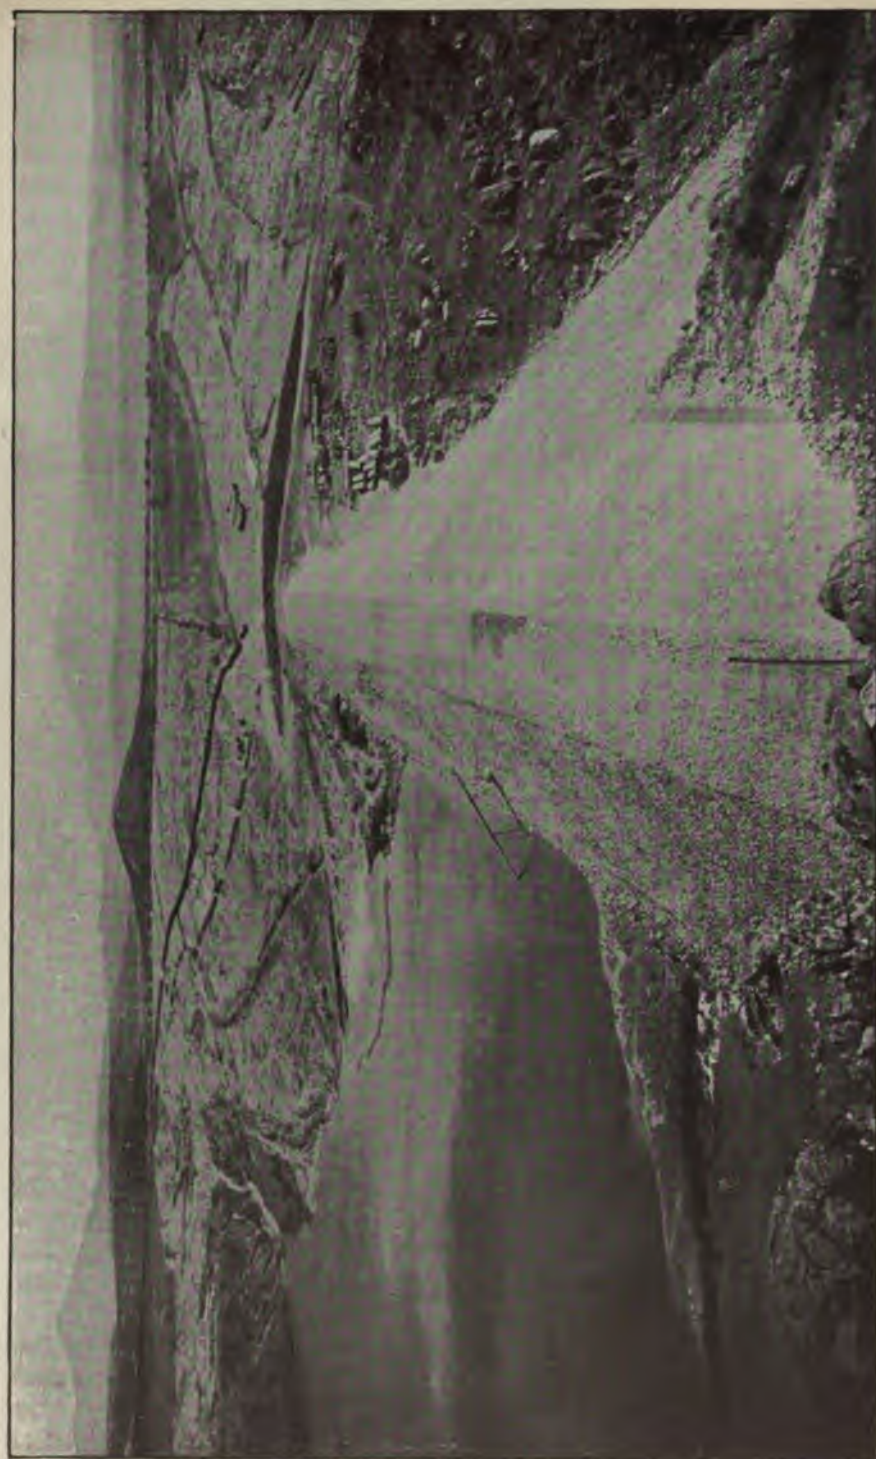
FIG. 70.—VIEW OF FINISHED DAM AND WASTEWAY OF LA MESA RESERVOIR.

In beginning the work a trench was excavated in bed-rock, as shown in Fig. 72, from 2 to 5 feet deep, 20 feet wide at center and tapering to 5 feet at the ends. At right angles to this trench in the bed of the gulch a culvert was built to reach entirely through the dam at its widest point. This culvert, whose details are shown in Fig. 73, consisted of a concrete conduit, 48 inches wide, 30 inches high, extending from the inner face of the dam outward 180 feet, to a point 72 feet from the lower toe, where it connects with two 24-inch cast-iron pipes, that form the outlet to the reservoir. One of these pipes connects with a wood-stave pipe supplying water to San Diego, and the other is used as a waste, or clean-out, pipe. Both are controlled by gate-valves at the toe of the dam. The walls of the concrete culvert are 12 inches in thickness, and four vertical stand-pipes connect with the culvert at intervals of 35 feet from the inside end. These stand-pipes consist of 24-inch vitrified pipes, surrounded with concrete, which pass upward through the body of the dam, and are now used as outlet-pipes to the reservoir at four different levels. During construction they performed the important function of conveying the water into the reservoir after it had dropped its load of gravel and sediment on to the surrounding embankment. They were built up a joint at a time in 2-foot sections, as the work progressed, and were finished off at the top with brass ring and flap-valve, the latter being controlled by rods reaching up the slope through the water to the surface. (See Fig. 70.) These flap-valves can only be opened when pressure is relieved by closing the gate-valves below.
